## Mitigating linear infrastructure: Artificial canopy bridges as a key mitigating tool to reduce golden langur (*Trachypithecus geei*) road accidents in Assam, India

## Abstract

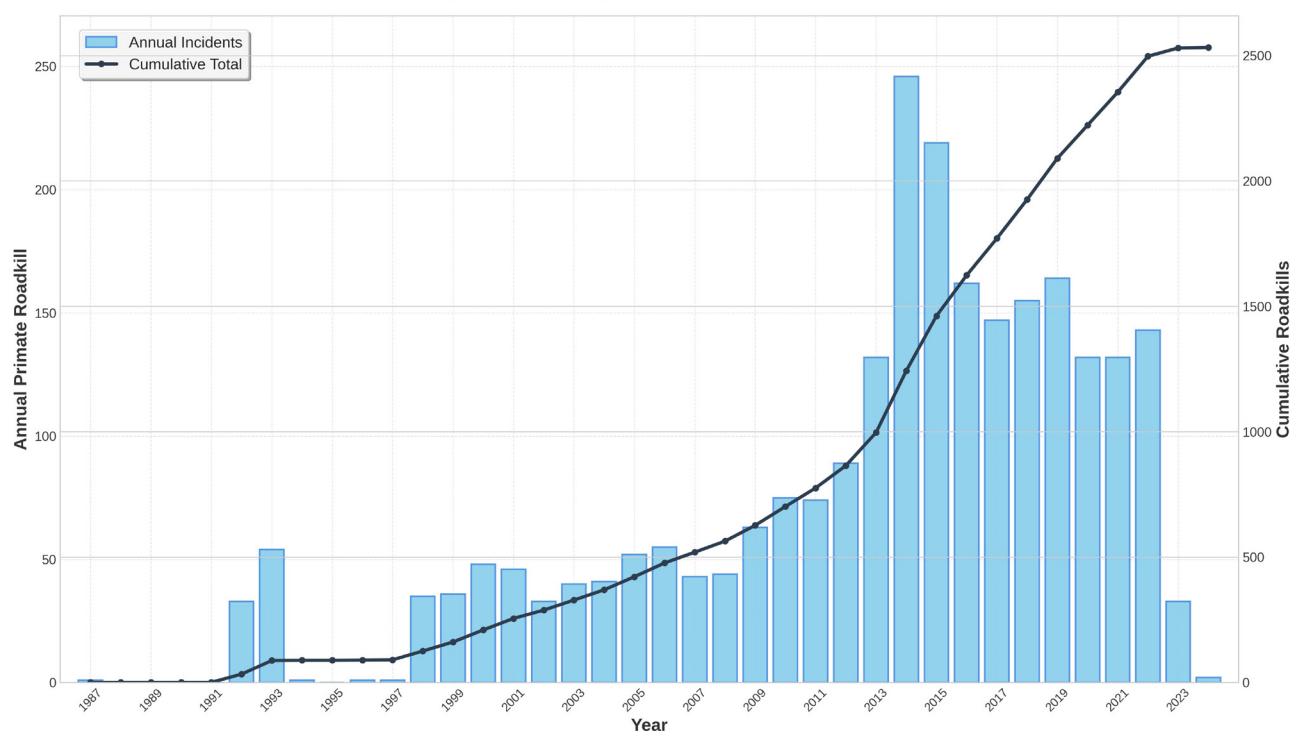
Figure 1: Report of the yearly number of primate road kills in the Global Primate Roadkill Database (GPRD), showing a gradual increase during 1987-2024 (bars), and an acceleration of records in the 2010s. The secondary axis provides the cumulative number of roadkill incidents (line). Data used are available from The Global Primate Roadkill Database compiled by Praill *et al.* (2023) (accessed at: <https://gprd.mystrikingly.com> on 7 August 2025).

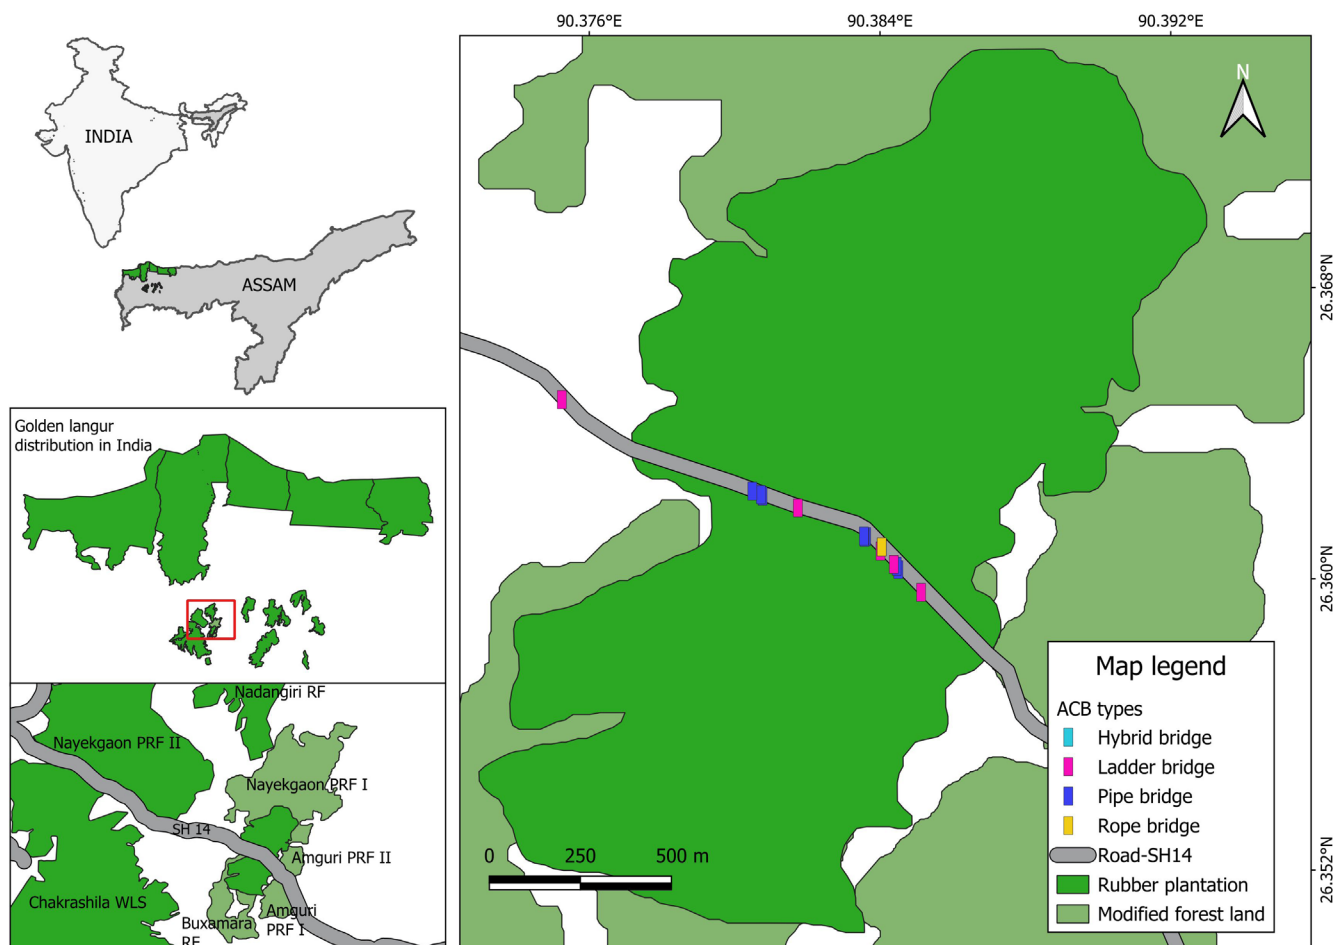
Figure 2: Fragmented forest habitats of the golden langur in Kokrajhar district, Assam, India, showing the locations of artificial canopy bridges (ACB).

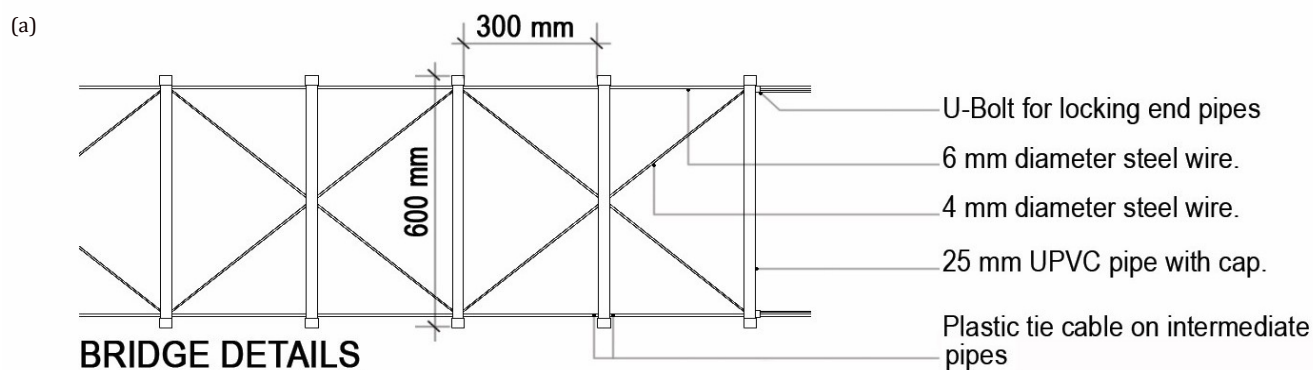
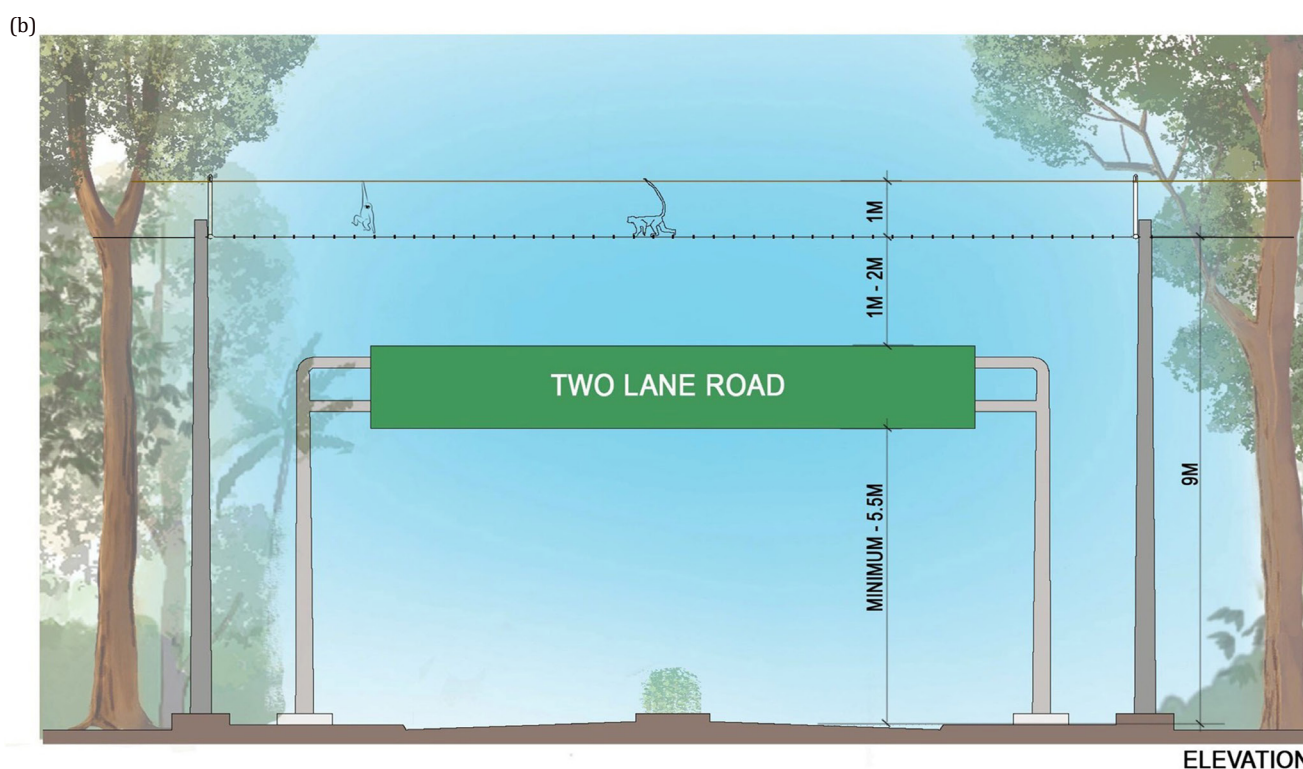
Figure 3: (a) Top view of the ladder bridge with the measurements. (b) Design for the ladder bridge for golden langurs.

**IV. Ladder bridge:** We used a 2.54 cm diameter UPVC hose pipe of 50 cm length. Both ends of the pipe were closed with a cap using UPVC joining solvent. The bridge was constructed in the style of a horizontal “ship” ladder, with its total length varying from 12 m to 15 m according to the width of the road. The core structure comprised four parallel insulated gym cables. The two outer cables (6 mm thick) remained straight and were spaced approximately 50 cm apart to provide the bridge’s main frame. The two inner steel cables (4 mm thick), that are commonly used in gym equipment, were arranged in an interlaced pattern, forming an “X” configuration between each step, spaced at intervals of 30 cm along the length of the bridge (see Figure 3a). At each end of every pipe, one 6 mm hole and one 4 mm hole were drilled using a drill machine, allowing the passage of both the outer and inner cables. In addition, at the midpoint of each pipe—corresponding to the “X” junction of the interlaced inner

cables - one 6 mm hole was drilled at each end and another at the centre. The crossing point of the “X” configuration was secured at this junction using a thick rope clamp, ensuring overall stability and preventing cable movement during use. We constructed five ladder bridges in Siljan, Kokrajhar. (Figure 6f).

All of the bridges were placed at a height of nine to ten meters from the ground (Figure 3b).

2.54 cm diameter UPVC hose pipe of length 50 cm. Both ends of the pipe were closed with a cap. Total length varying from 12 m to 15 m according to the width of the road. The core structure comprised four parallel insulated gym cables. The two outer cables (6 mm thick) remained straight and were spaced ~50 cm apart to provide the bridge's main frame. The two inner steel cables commonly used in gym equipment (4 mm thick) were arranged in an interlaced pattern, forming an "X" configuration between each step at intervals of 30 cm. The steps were spaced 30 cm apart along the length of the bridge. At each end of every pipe, one 6 mm hole and one 4 mm hole were drilled using a drill machine, allowing the passage of both the outer and inner cables. In addition, at the midpoint of each pipe—corresponding to the "X" junction of the interlaced inner cables - one 6 mm hole was drilled at each end and another at the centre. The crossing point of the "X" configuration was secured at this junction using a thick rope clamp.

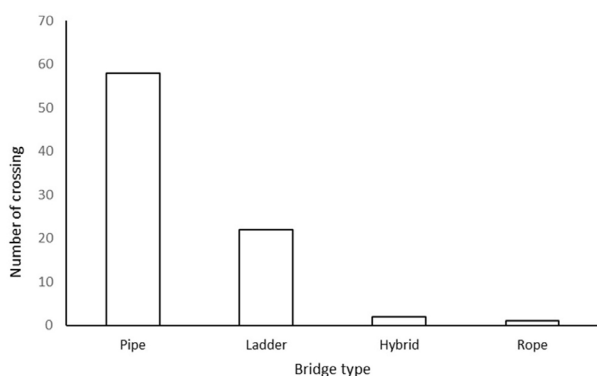
Figure 4: Frequency of use for different designs of artificial canopy bridges by the golden langur in Kokrajhar district, Assam, India.

We recorded 112 instances of golden langurs crossing the road during the monitoring period. Langurs used the canopy bridges (74.0 %,  $n = 83$ ) significantly more than the road (25.8 %,  $n = 29$ ) ( $\chi^2 = 26.04$ ,  $df = 1$ ,  $p < 0.01$ ). Further, out of 83 crossings using canopy bridges, 69.9 % ( $n = 58$ ) were using pipe bridges, 26.5 % ( $n = 22$ ) of the crossings were using ladder bridges, 2.4 % ( $n = 2$ ) of the crossings were using hybrid bridges and 1.2 % ( $n = 1$ ) of the crossings were using rope bridges, ( $\chi^2 = 102.69$ ,  $df = 3$ ,  $p < 0.001$ ) (Figure 4).

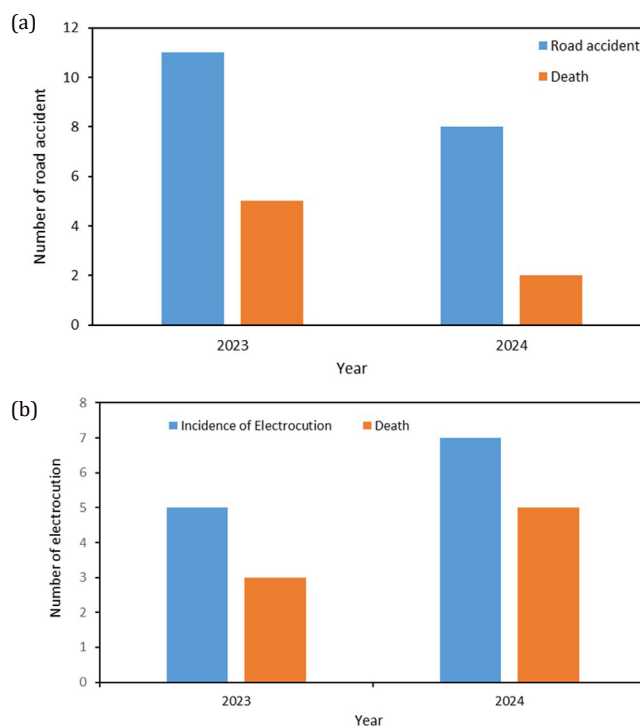
Figure 5: (a) Number of langur collisions with vehicles and deaths that occurred during the period of pre and post canopy bridge installations in Kokrajhar district, Assam, India. (b) Number of langur electrocution and their deaths during the period of pre and post canopy bridge installations in Kokrajhar district, Assam, India.

Between January 2023 and December 2024, we documented a total of 18 golden langur road collisions on SH-14 (Figure 5a). Of those, 11 collisions leading to five deaths occurred before installing the canopy bridges, while two deaths due to seven collisions occurred after installing the canopy bridges. Out of 18 collision incidents in total, langurs were killed in seven incidents, sustained major injuries, that mainly included broken legs or the amputation of palms or tails in five incidents, and langurs escaped with minor injuries in the other six incidents. Meanwhile, there were three deaths of langurs in the five electrocution incidents in the period of pre canopy bridge installations, whereas we recorded five deaths in seven electrocution incidents in the period of post canopy bridge installations where electric power lines were not insulated.

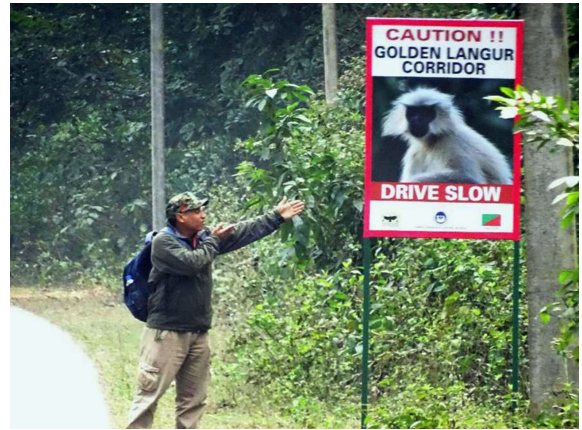
B: Signage board and traffic signalling.

Observers were stationed from June to August, 2023, two days a month, to signal passing the vehicles passing at high speed to reduce their speed at an accident-prone area, where there were high possibilities of animal crossings. Observers signalled a total of 50 vehicles when golden langur groups were active close to the roadside or attempting to cross and recorded the responses of the commuters. Vehicles' speed compliances were observed visually without a speedometer. Speed compliances were considered positive when vehicles used a full break or decreased their speed significantly. In September 2023, we erected two signage at both ends of the accident-prone area of the road to educate and signal the traffic. We further continued signalling vehicles to reduce their speed for two days a month, from September to November 2023. For comparison, observers signalled to another 50 vehicles while golden langur groups were near the roadside, keeping the signage in focus.

We recorded every langur collision with vehicles and other causes of their death along the road. Using this information, we identified the crucial location of animal crossings and possible animal collision sites. (Figure 6a and Figure 6b).

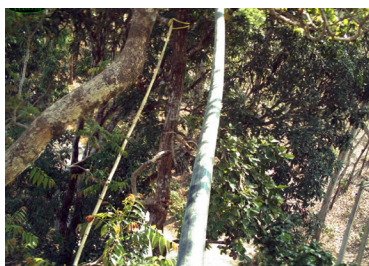
C: Bamboo cum rope (hybrid) bridge

b. Bamboo poles measuring 3 cm in diameter were sliced into 10 cm lengths. These pieces were then threaded onto a 2.4 mm diameter nylon rope, forming a flexible yet sturdy bamboo chain. Once assembled, the rope cum bamboo chain bridge was installed between two anchor trees by securely fastening it to the branches. (Figure 6c)

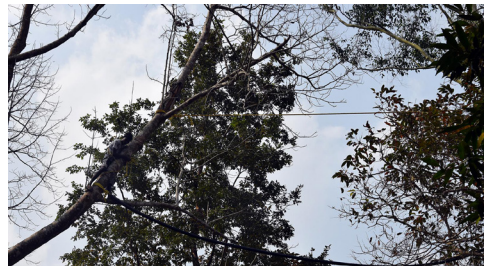
D: Rope bridge (upper one)

**II. Rope bridge:** The bridges were constructed using thick yellow coloured nylon rope with a diameter of 2.4 cm, securely tied to pre-identified anchor trees. The ropes were fastened to branches at a height of approximately 1.5 to 2 meters above the electric lines crossing the road, thereby eliminating any risk of electrocution. (Figure 6d)

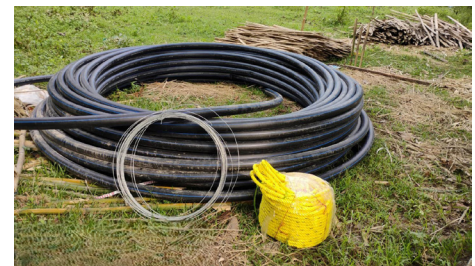
E: High-density polyethylene (HDPE) pipes (6.08 cm diameter, typically used for water supply), 2.4 cm diameter nylon rope and 4 mm galvanised wire.

**III. Pipe bridge:** The bridges were constructed with HDPE pipes (5.08 cm diameter, typically used for water supply), combined with 2.4 cm diameter nylon rope and 4 mm galvanised wire. Considering the width of the canopy gap, the HDPE pipe was cut to the required length. A 2.4 cm diameter nylon rope and a 4 mm galvanised wire were inserted through the pipe, with an excess length of 6–8 meters on either end to allow the pipe to secure on the anchor trees. Two small holes were drilled at both ends and every 4 m of the HDPE pipe. The inserted rope and galvanised wire were tightly secured to the pipe with 0.75 mm steel wire at the drilled holes of the pipe. This provided additional stability and ensured that the rope remained firmly in place within the pipe. The bridge was lifted and positioned across the preselected canopy gap. The ropes were then securely fastened to strong branches on each side of the designated anchor trees. A total of eight pipe bridges were installed at the identified locations. (Figure 6e)

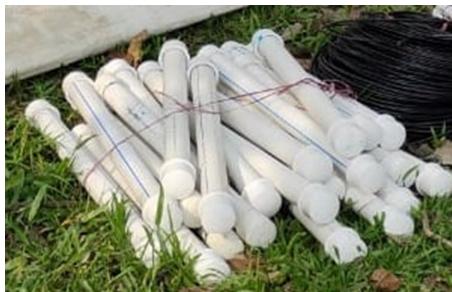
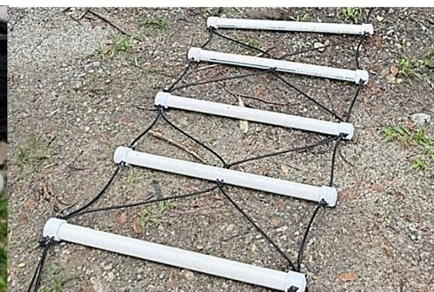
F: (i) 6 mm Gym cable & 2.54 cm diameter UPVC pipe (ii) Pierce holes at both ends and the centre

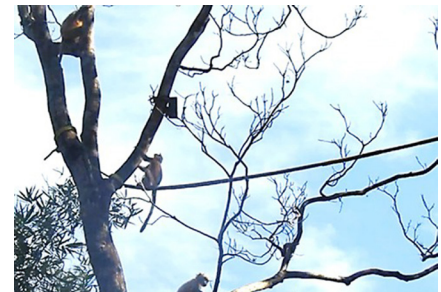
G: Bamboo cum Rope bridge (hybrid) used by golden langur

We installed 15 canopy bridges along the SH-14, comprising eight pipe bridges, five ladder bridges, one rope bridge and one hybrid bridge (developed by replacing the bamboo-pole bridge) (Table 1). The time taken by the langurs to get habituated to using the different ACBs varied depending on the materials used; however, they eventually adapted to using them. Golden langurs habituated to the bamboo pole bridge and rope bridge within 15 and 23 days of installation (Figure 6g & 8h), respectively. After the acclimatisation phase, the bamboo-pole bridge was replaced with a mixed bamboo-and-rope structure (hybrid bridge). In contrast, pipe bridges took slightly longer, with an average habituation period of 29 days (Figure 6i). During the acclimatisation phase, golden langurs quickly started using the bamboo canopy bridges over the rope bridge (Figure 6h). Ladder bridges initially required a longer habituation period

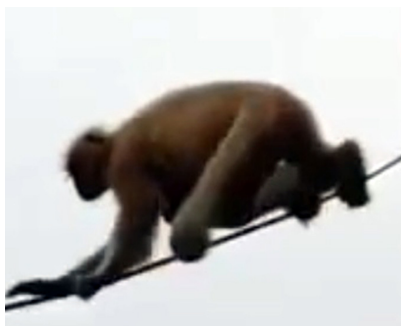
H: Rope bridge used by golden langur

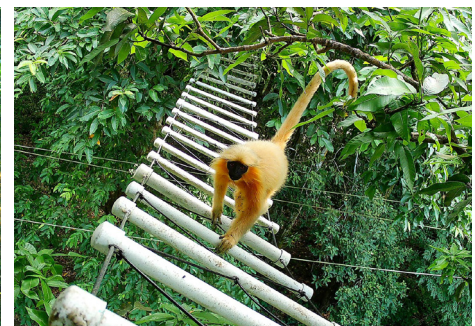
J: Ladder bridge used by the golden langur

nearly 90 days before the first observed crossing but this duration decreased to ~ 65 days in subsequent installations (Figure 6j).
